Laboratory Test Report

Hydraulics Laboratory
School of Engineering and Technology
Asian Institute of Technology
P.O. Box 4, Klong Luang
Pathumtani 12120, Thailand

Hydrostatic Pressure Test on Cast-in Place Concrete Construction Joints with “Bond Swelling” Waterstop

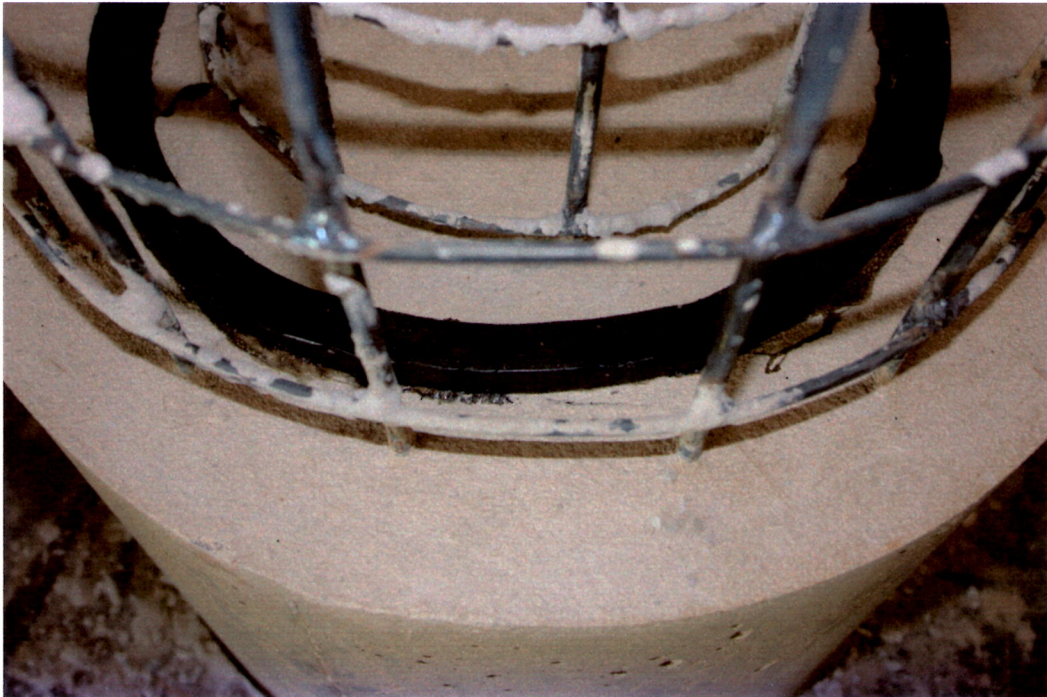
Photograph 1 - **Bond Swelling** installed along the construction joint of the concrete test chamber

The construction was carried out in three stages, i.e., base, lower wall and upper wall. Along each construction joint, a sample of **Bond Swelling** waterstop was installed using primer adhesive. The waterstop was installed following the general instructions set by the manufacturer.

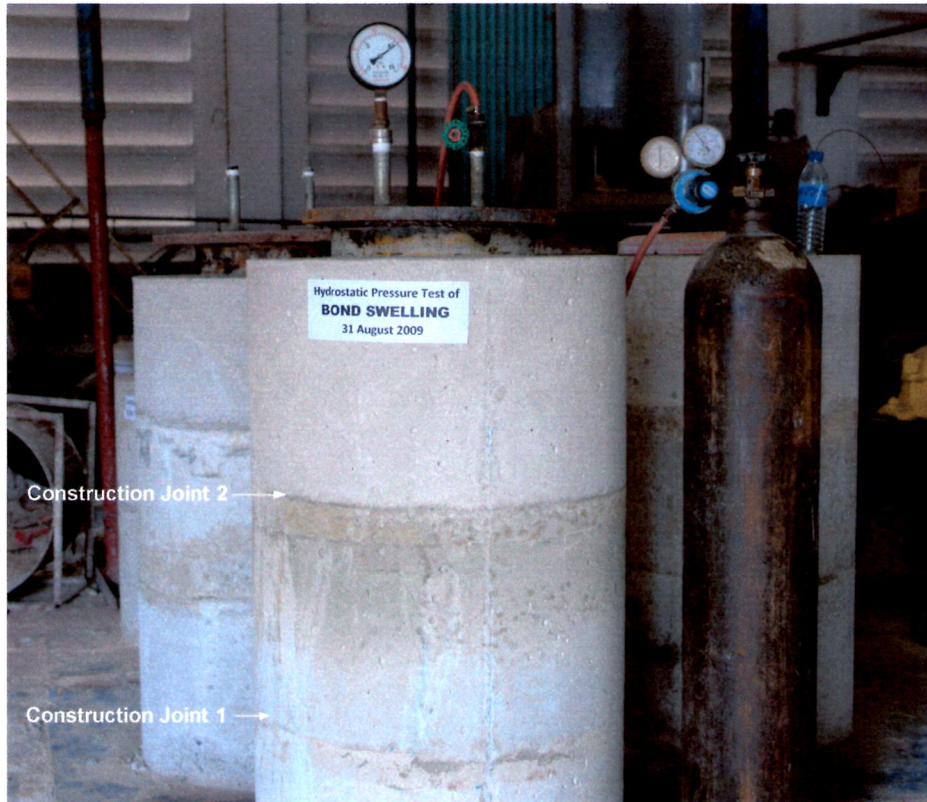
Photograph 3 – Concrete test chamber at 100 psi pressure; no leakages along the construction joints were noted.
